Task Order No. 2 REPORT

RAMP TOLL PLAZA CONVERSION SYSTEMWIDE

ILLINOIS TOLLWAY Project No. 1-06-5511

Task Order No. 2 Report

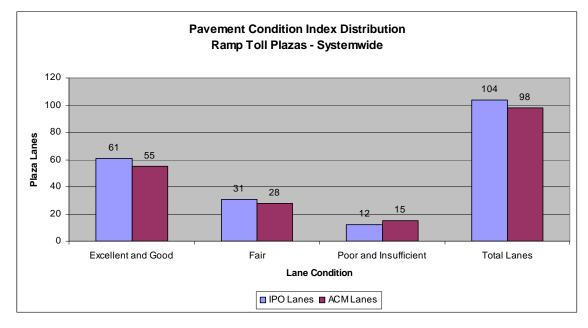
PAVEMENT CONDITION INDEX

A number of 88 ramp toll plazas have been surveyed and entered into the database, for a total of 202 plaza lanes. (104 IPO and 98 ACM). Most of the recorded data has been entered into the database; however newer information and certain older plans were not obtainable for review. Consequently recorded data regarding pavement thickness, reinforcement depth and pavement age has been obtained for approximately 90% of the data.

The pavement condition distribution, as obtained, is presented below:

A. The plaza lanes having a PCI condition of excellent, good and fair are possible candidates for immediate short-term electronic conversion actions. Plaza lanes having indices of poor and insufficient need either localized full depth repairs or overlays; depending on the pavement age, poor and insufficient plaza lanes may be reconstructed. Exhibit C presents a comprehensive view of all plaza lanes.

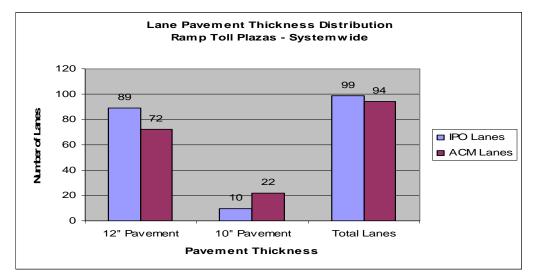
PAVEMENT THICKNESS

At this time, pavement thickness from record data has been obtained for 193 plaza lanes, or 95.5% of total. A 12"-thick continuously reinforced concrete pavement (CRCP) is present in 83% of recorded pavement data. Presently, the pavement thickness distribution is presented below:

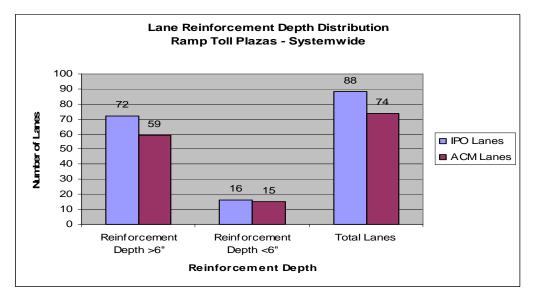
PAVEMENT REINFORCEMENT

At this time, pavement reinforcement depth from record data has been obtained for 162 plaza lanes, or 80.9% of total. A 6-inch pavement reinforcement depth was present in 80.2% of recorded pavement data. Presently, the pavement reinforcement depth distribution is presented below:

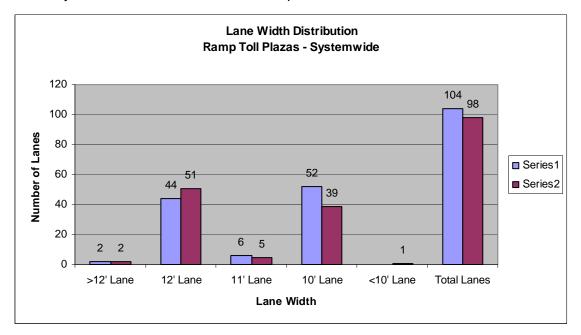
LANE WIDTH

10'-lanes represent 45.5% of the lanes. 12'-lanes represent 47% of the lanes.

Presently, the distribution of lane widths is presented below:

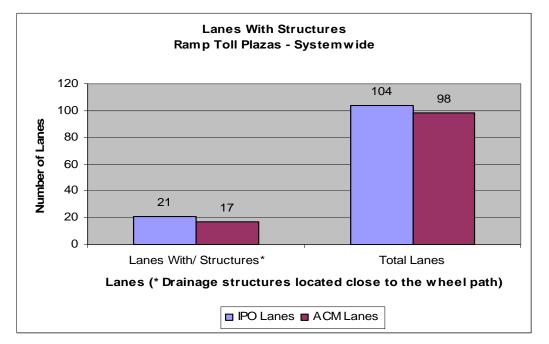
LANE DRAINAGE STRUCTURES

Drainage structures are present in 18.8% of the lanes.

Presently, the distribution of the drainage structures is presented below:

E. The plaza lanes where drainage structures were observed were noted for

possible interference with electronic conversion implementation.

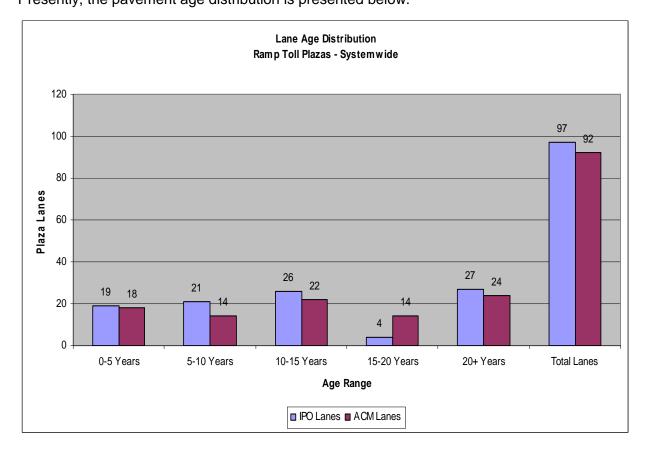
PAVEMENT AGE

At this time, pavement age from record data has been obtained for 189 plaza lanes, or 93.6% of total. Pavement older than 20-years represents 27% of the recorded pavement data. Presently, the pavement age distribution is presented below:
