## **ABBREVIATED BRIDGE CONDITION REPORT**

**CONTRACT NUMBER:** RR-10-5614

**BRIDGE DESCRIPTION:** Annie Glidden / DeKalb West Road over Ronald Reagan Memorial Tollway (I-88)

**BRIDGE NUMBER** 1131 (Tollway), 019-9907 (IDOT)

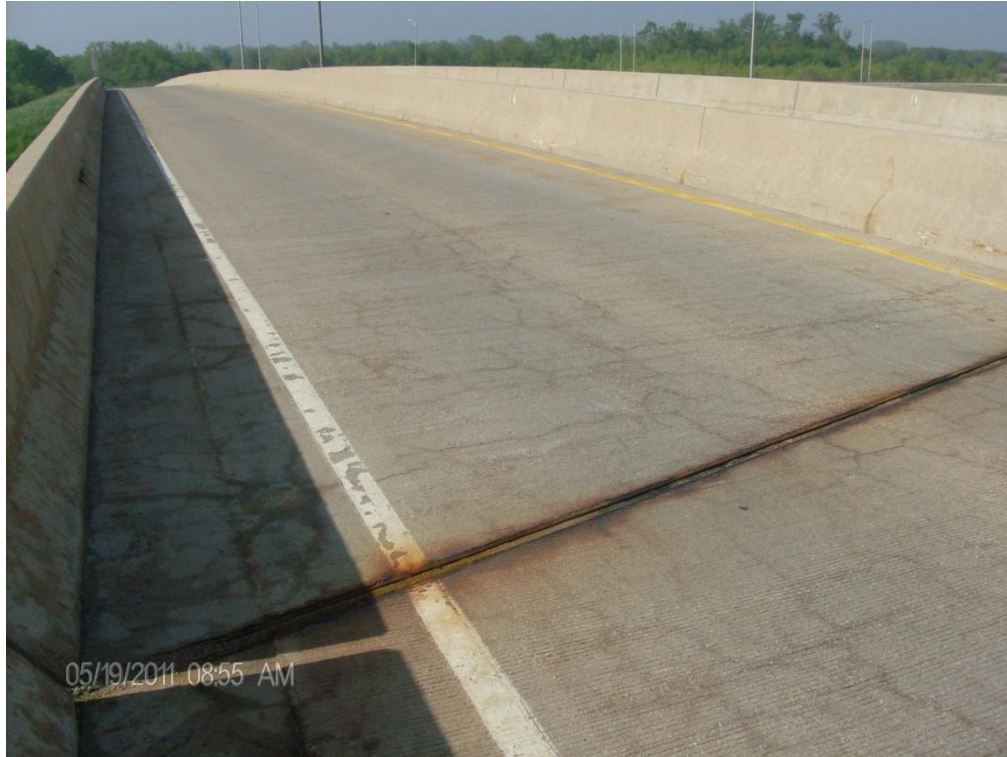
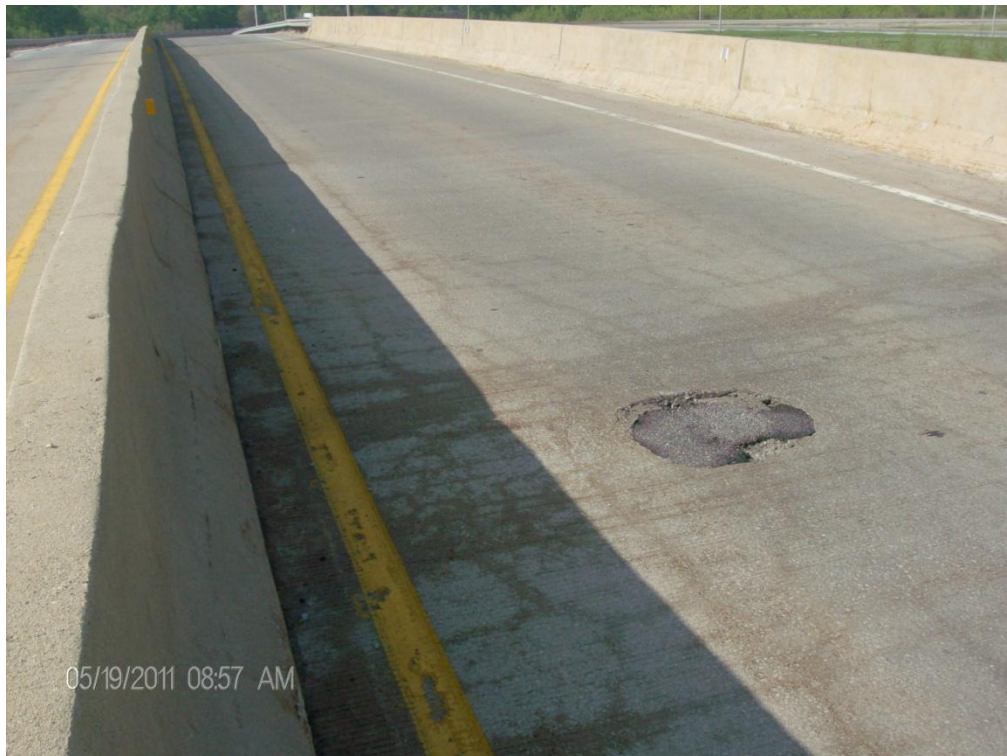
The deck was rated as good (NBIS Rating = 7) in the 2010 Structure Inspection Field Report. The deck condition observed in this field inspection concurs with the previous rating. The top of deck was not inspected for delaminations and there appears to be a fair amount of map cracking, but spalling is minimal and the overall top of deck condition appears good. For typical conditions, see Attachment B – photos 1 and 2.

**Photo 1: Northbound Top of Deck, looking South from the North Expansion Joint**

**Photo 2: Southbound Top of Deck, looking South from the center of structure**

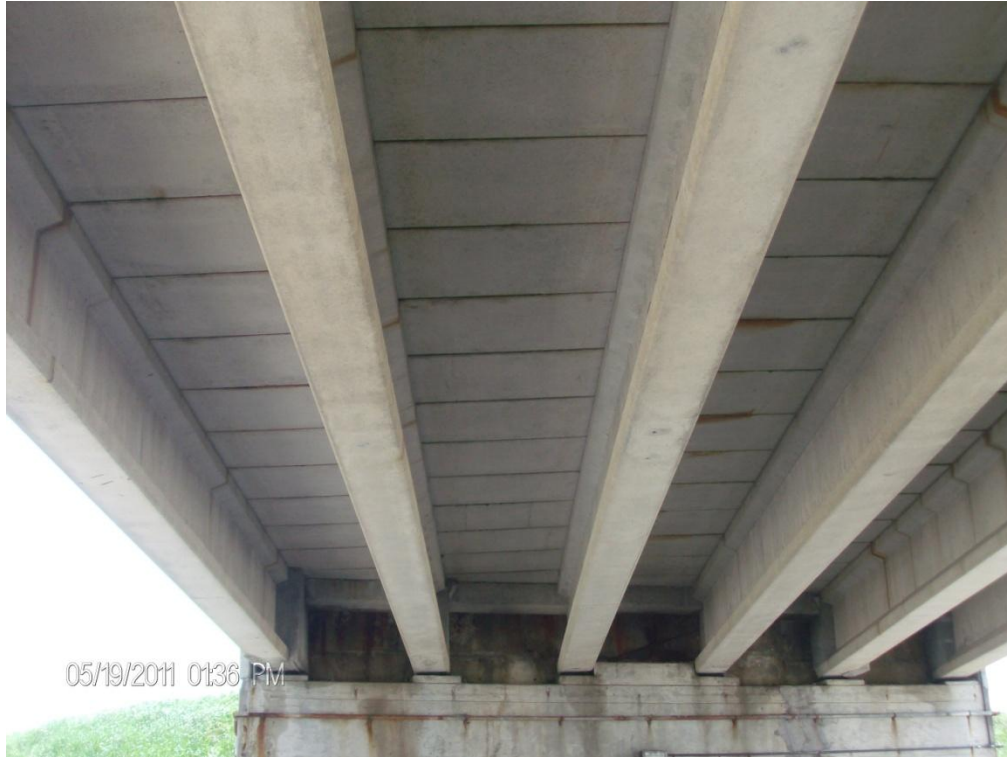
At the deck underside only the precast plank stay-in-place forms are visible (except at the deck overhangs). The south main span planks have minimal transverse cracks (2 cracks noted) and have minimal spalling (0.5% of deck area). For typical conditions, see Attachment B – photo 3. 18 ft<sup>2</sup> of the spalling is noted in the westmost bay at the pier diaphragm. Additionally, the bottom of the thickened slab edge at the South Abutment is spalled for about 80% of the deck width.

**Photo 3: South Span Deck Underside, Looking North toward the Median Pier**

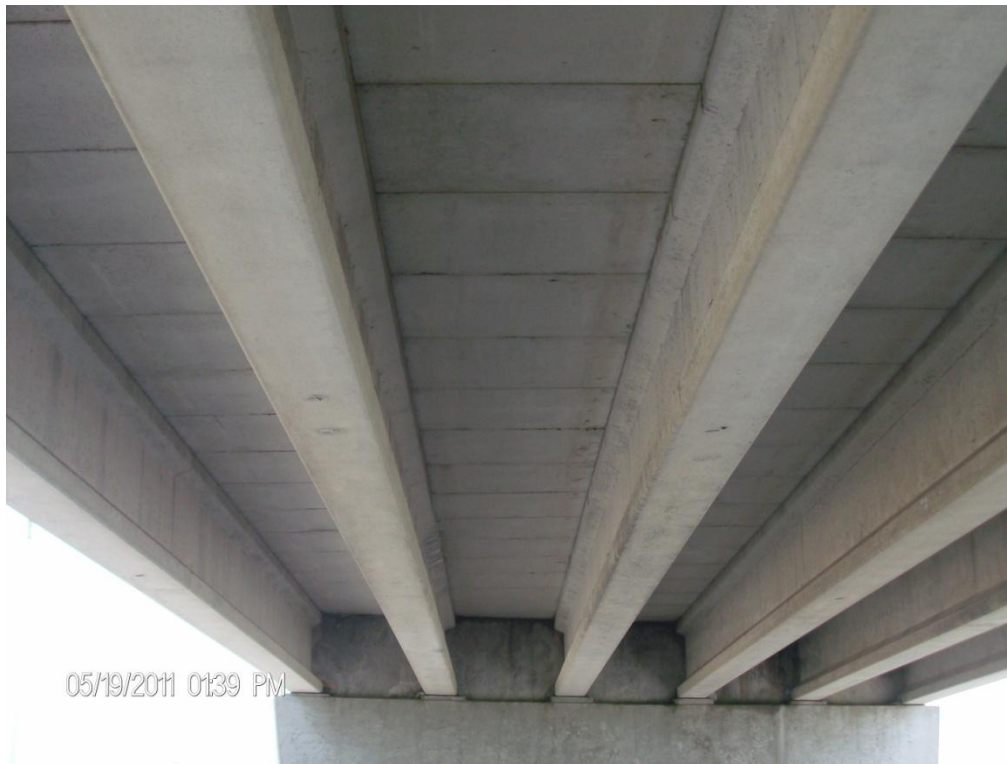
The north main span planks have no significant transverse cracking. Approximately 1.3% of the underside is spalled, nearly all of which is located along the south end of the span, along the pier diaphragm. Heavy leaching and stalactites were noted along 16' of Beam 5 near the median pier. For typical conditions, see Attachment B – photo 4. Additionally, the bottom of the thickened slab edge at the North Abutment is spalled approximately 4' long.

**Photo 4: North Span Deck Underside, Looking South toward the Median Pier**

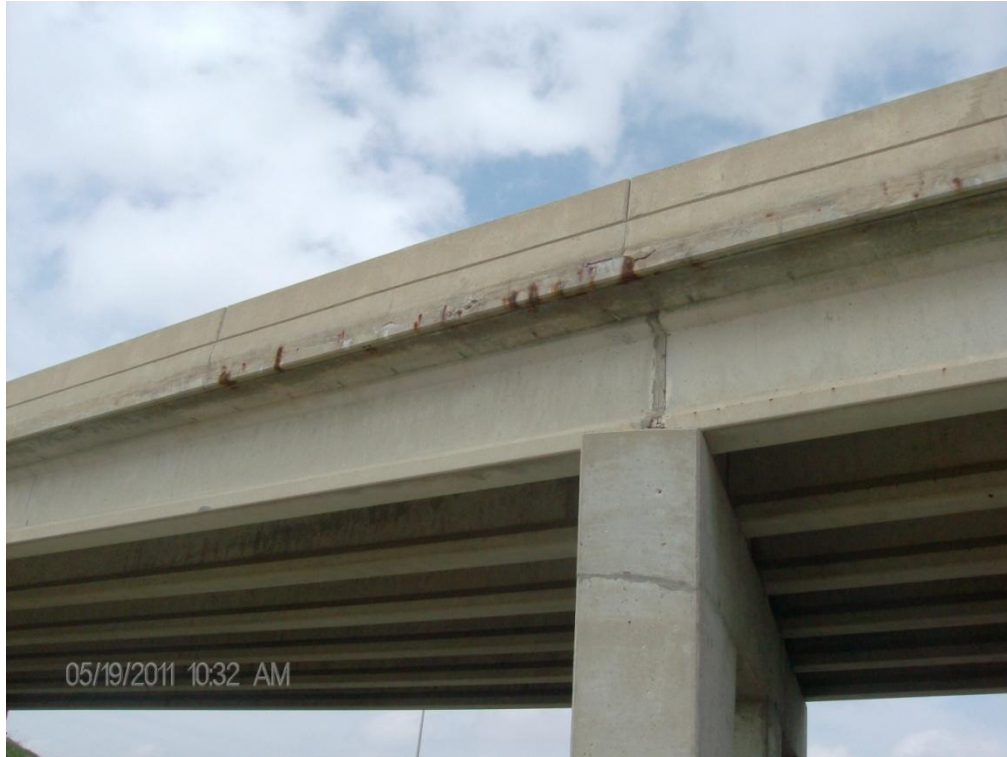
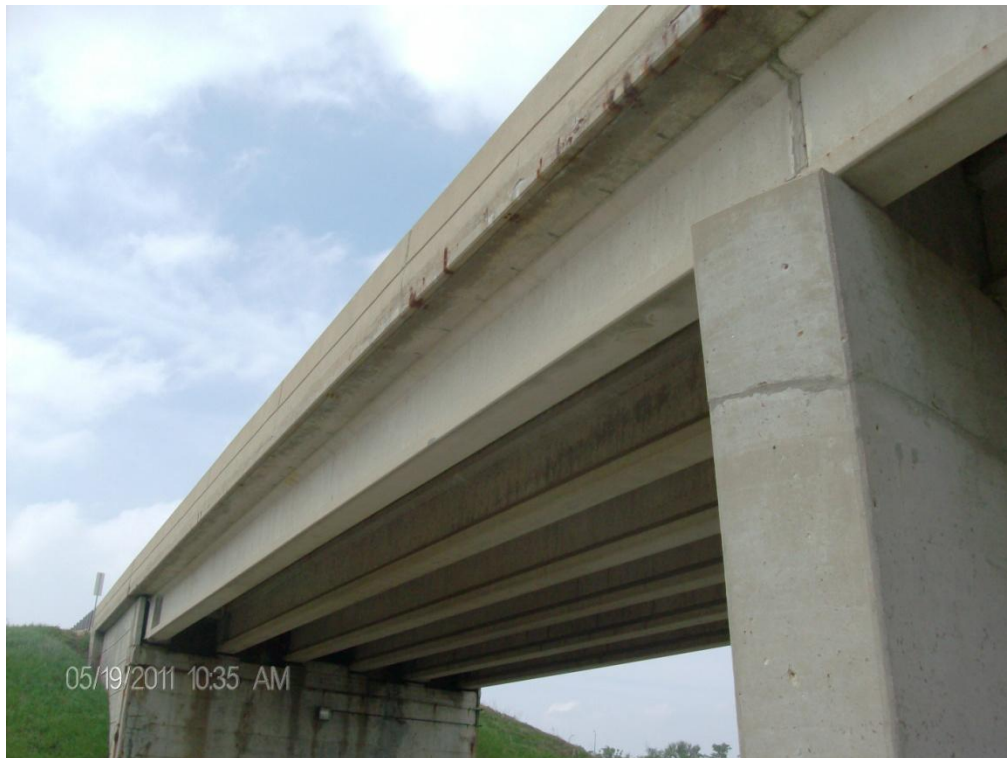
A 20 foot segment of the bottom one foot of the outside of the east parapet had heavy rust staining with a few small popouts. Much of this area was sounded and no delaminations were found. See Attachment B – photos 5 and 6.

**Photo 5: Spalling & Delaminations along the bottom 1' of East Parapet, about 20' long**

**Photo 6: Typical East Parapet condition, Span 1**

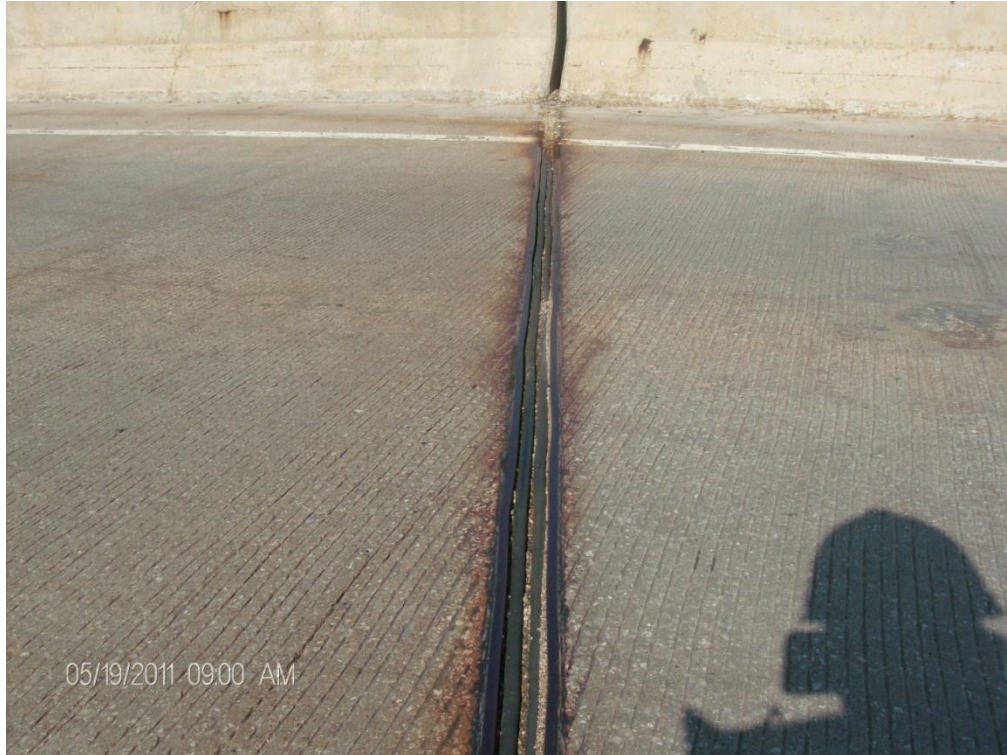
The expansion joint at the South Abutment is in poor condition. Sand and dirt have accumulated along the South joint. See Attachment B – photo 7. The entire South Abutment backwall below the joint was wet during light rain. Also, as noted above, the underside of the thickened slab edge is spalled along 80% of the length. The expansion joint at the North Abutment is also in poor condition. Sand and dirt has accumulated along the joint, and although the joint appears intact, about half of the North Abutment backwall below the joint was wet during light rain. See Attachment B – photo 8.

**Photo 7: SB Expansion Joint at South Abutment**

This repair applies to the expansion joints above the two abutments. Strips seal expansion joints are recommended. Full depth removal and replacement of the concrete deck end will be included to install the joints.

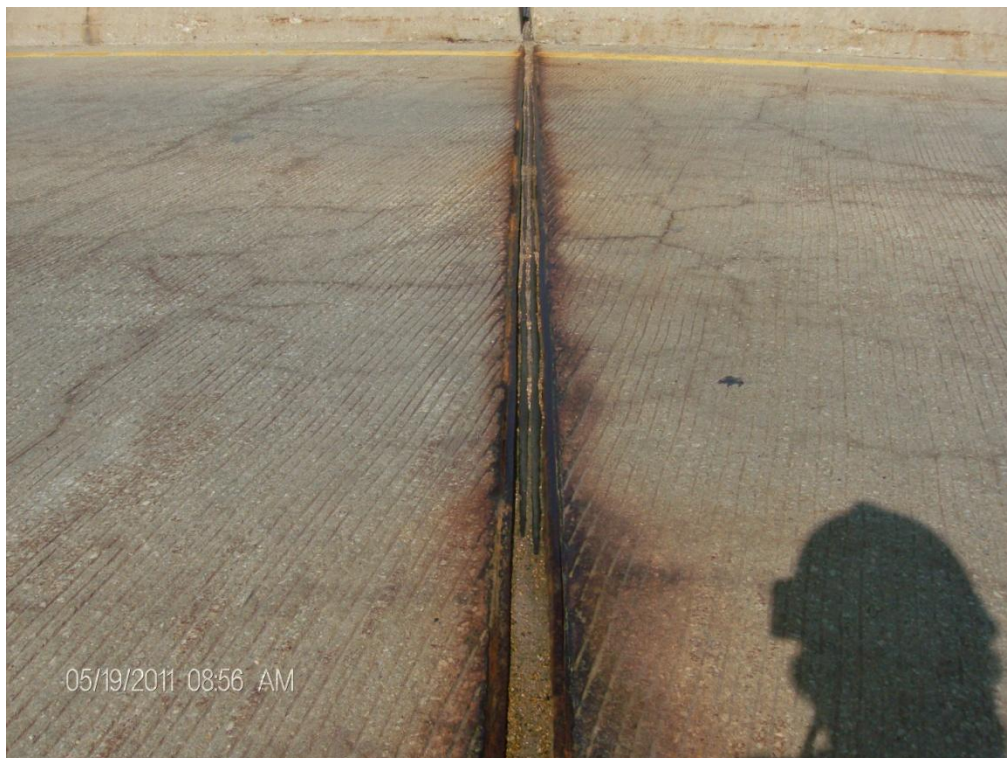
**Photo 8: NB Expansion Joint at North Abutment**

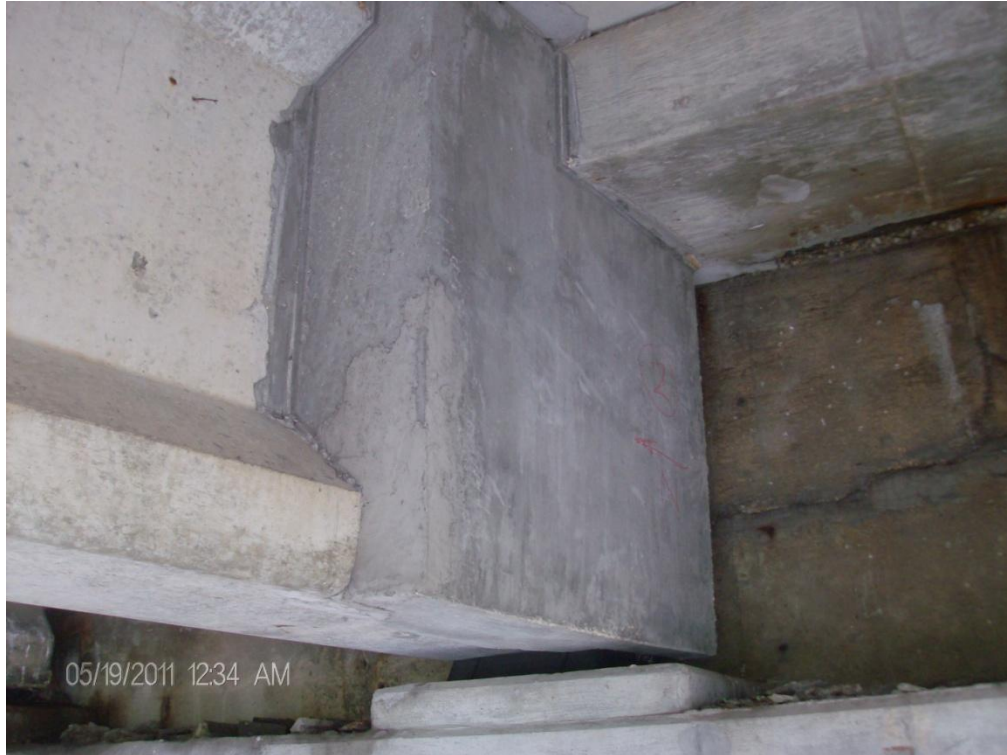
At the South Abutment, the ends of Beams 1, 2, 5, and 6 were previously encased with concrete at least 1'-6" in length. For an example of concrete end encasement, see Attachment B – photo 9. The sides of the beam-end bottom flanges are spalled with exposed strands and stirrups at the following locations: Beam 1 – west side, Beam 2 – east side, Beam 3 – west side. The spalls are about 6" to 8" long. Also, the west side of the bottom flange at the end of Beam 4 is delaminated for a length of about 8", and the east side of the bottom flange at the end of Beam 3 is delaminated for a length of about 18". The Beam 3 delamination extends about halfway into the sloped portion of the bottom flange. See Attachment B – photo 10. The end 4 feet of the Beam 6 bottom flange at the South Abutment is in particularly poor condition. Five strands are exposed, two of which have completely rusted away. See Attachment B – photo 11. There is a 3'-3" long delamination on the west side of the top flange at the North end of Beam 6. There are bottom flange spalls with exposed strands at the north end of Beams 1 and 6. All other south main span beams are in good condition at the pier.

**Photo 9: Concrete End Encasement at South Abutment, Beam 2**

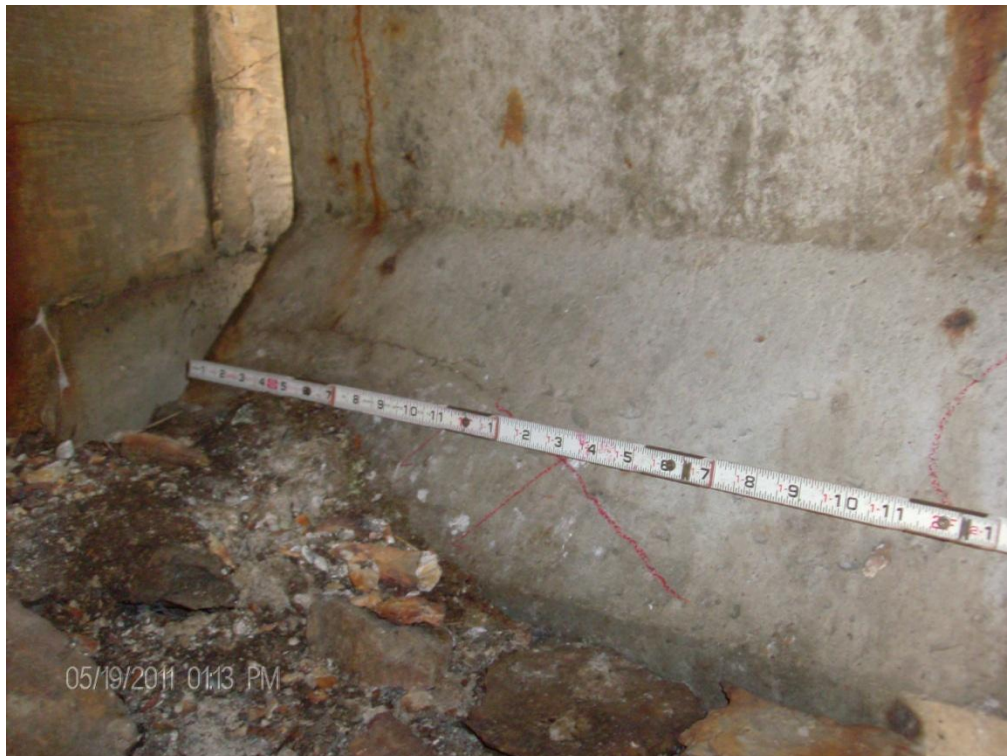
**Photo 10: Beam 3 bottom flange delamination at the South Abutment**

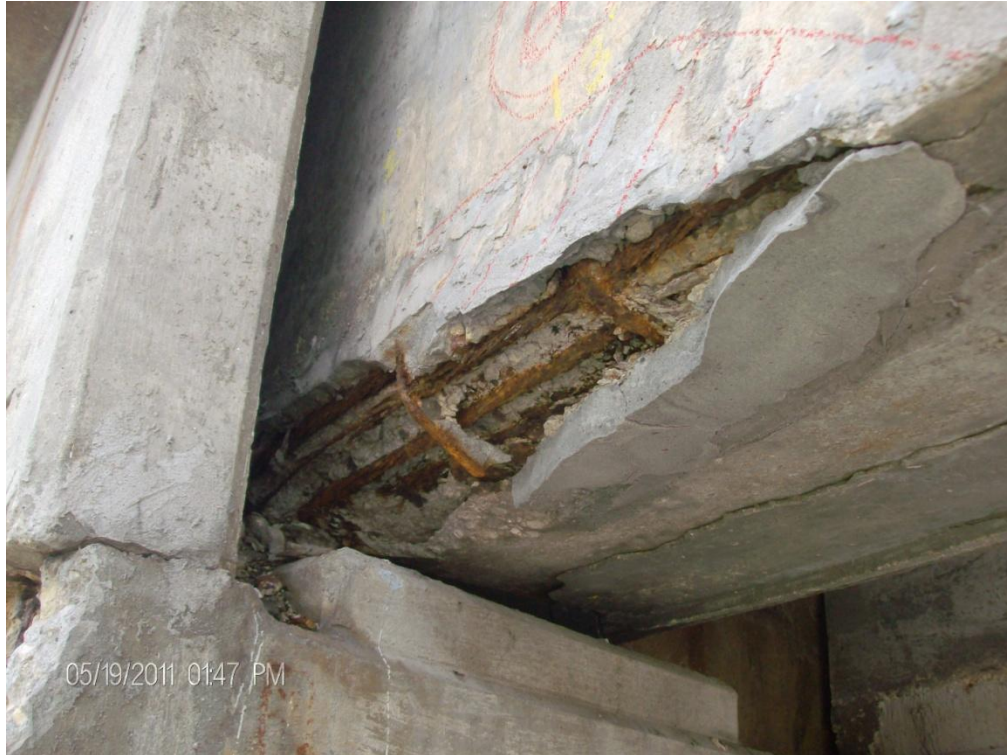
**Photo 11: Beam 6 Spalling & Delamination at the South Abutment**

The south end of this beam in Span 1 was previously repaired by encasing it with concrete for a length of 5'-9" from the south end. The proposed repair will focus on the bottom of the beam for a repair length of at least 4'-0'. It is anticipated that the bottom of the beam will be chipped to sound concrete and patched or formed with Polymer Modified Portland Cement Mortar. It is further anticipated that Fiber Wrap Repair will be wrapped around the bottom of the beam to provide additional strength to the repair. Beam replacement would be recommended if the life of the repair were to go further than 10 years.

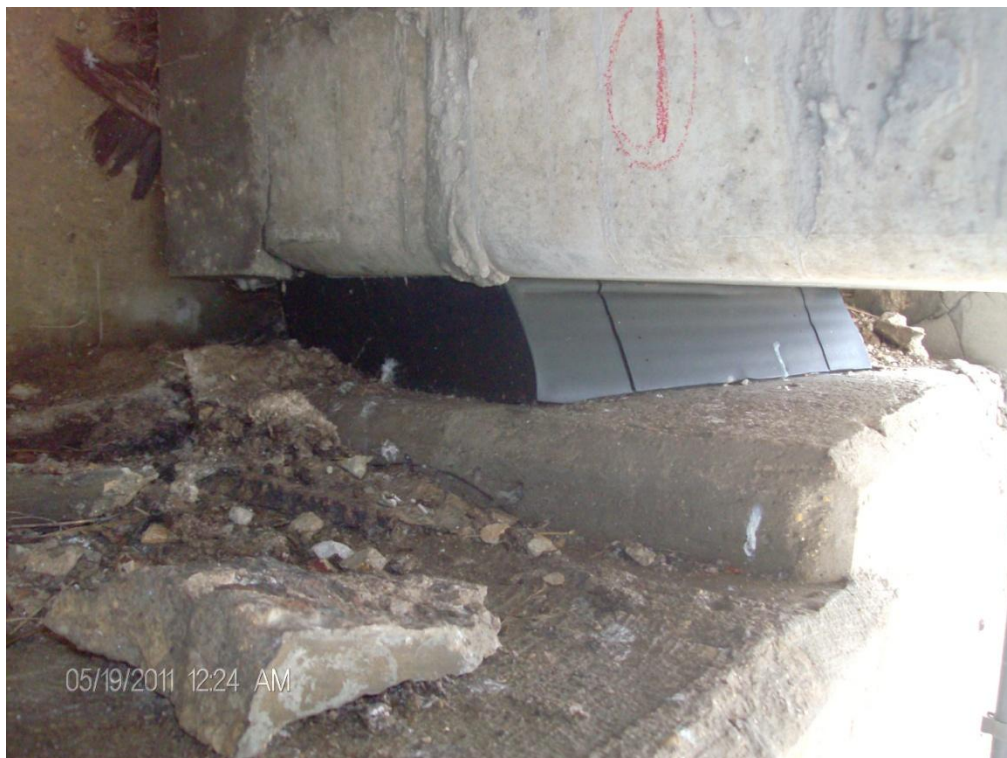
At the South Abutment, there is slight lift-off at the corner of the Beam 1 bearing. See Attachment B – photo 12. All of the bearings were leaned in the expansion direction 1” to 1¼” in 60-65 degree weather, indicating excessive bearing deflection.

**Photo 12: Slight lift-off of Beam 1 Bearing corner at South Abutment**

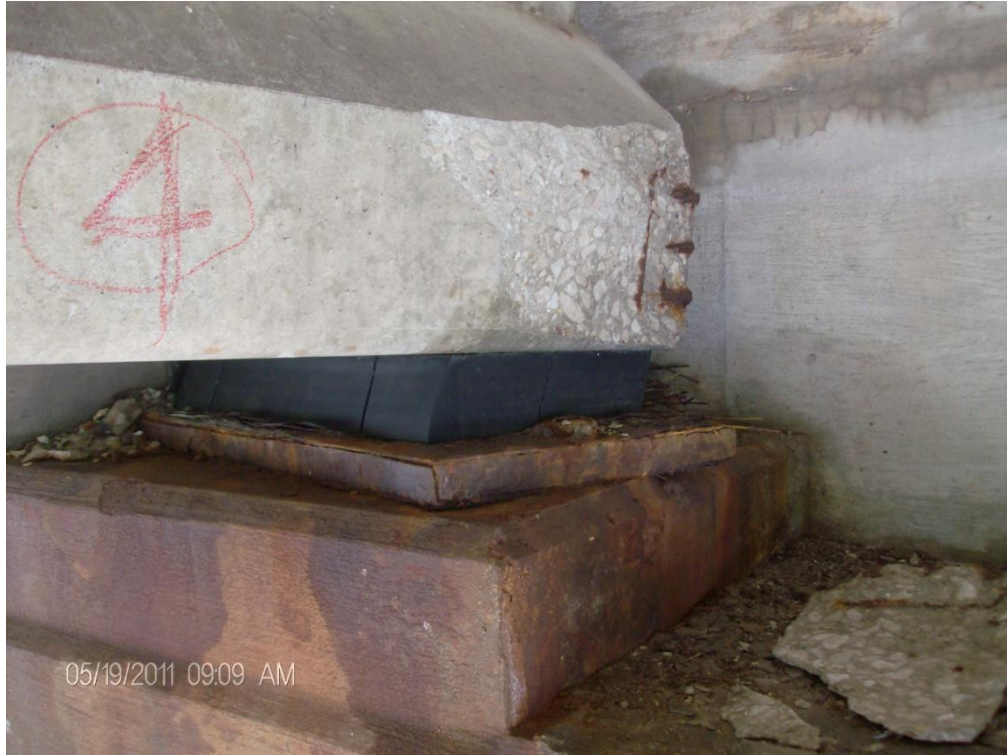
At the North Abutment, there is slight lift-off at the bearings for Beams 1, 3, and 5. All of the bottom bearing plates at the North Abutment are heavily rusted with flaking and pitting. For an example of bearing plate deterioration, see Attachment B – photo 13. All of the bearings were leaned in the expansion direction 1¼” to 1½” in 60-65 degree weather, again indicating excessive bearing deflection. For an example of excessive bearing deflection, see Attachment B – photo 14.

Nine of the 12 elastomeric expansion bearings at the abutments were noted to be in the expanded, deflected position of 1" to 1 1/4" at a temperature of about 60° F. The six bearings at the North Abutment have steel bottom plates that are heavily rusted and are either flaking or pitted.

**Photo 13: Heavy rusting & flaking at Beam 4 Bearing, North Abutment**

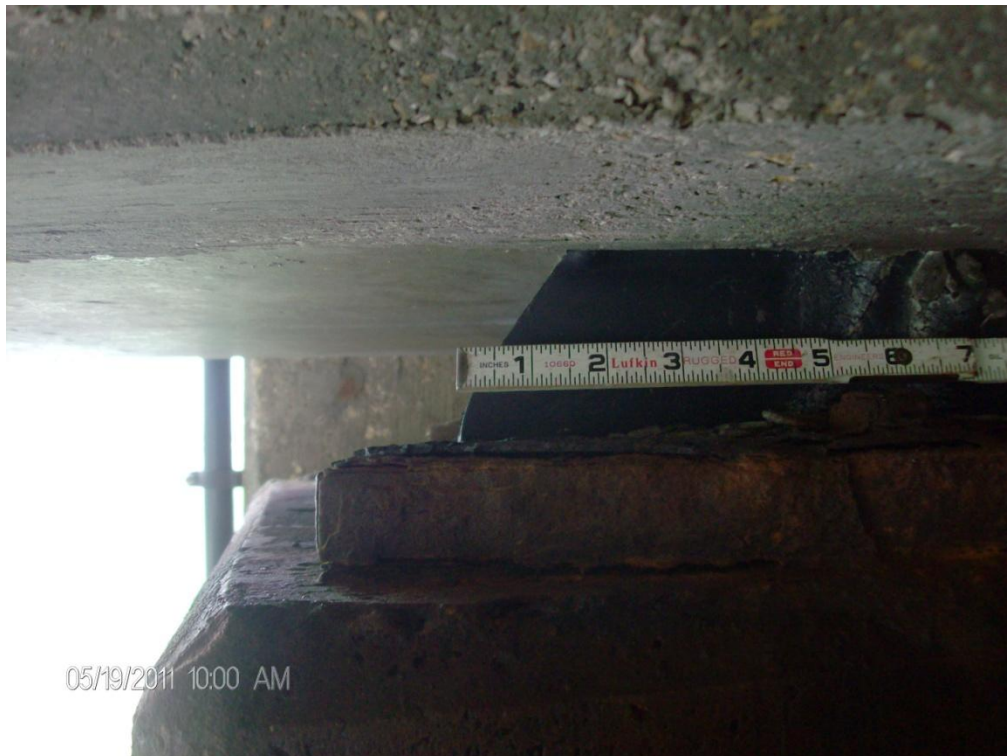
**Photo 14: Beam 1 North Abutment bearing expanded about 1½" in 65° weather**

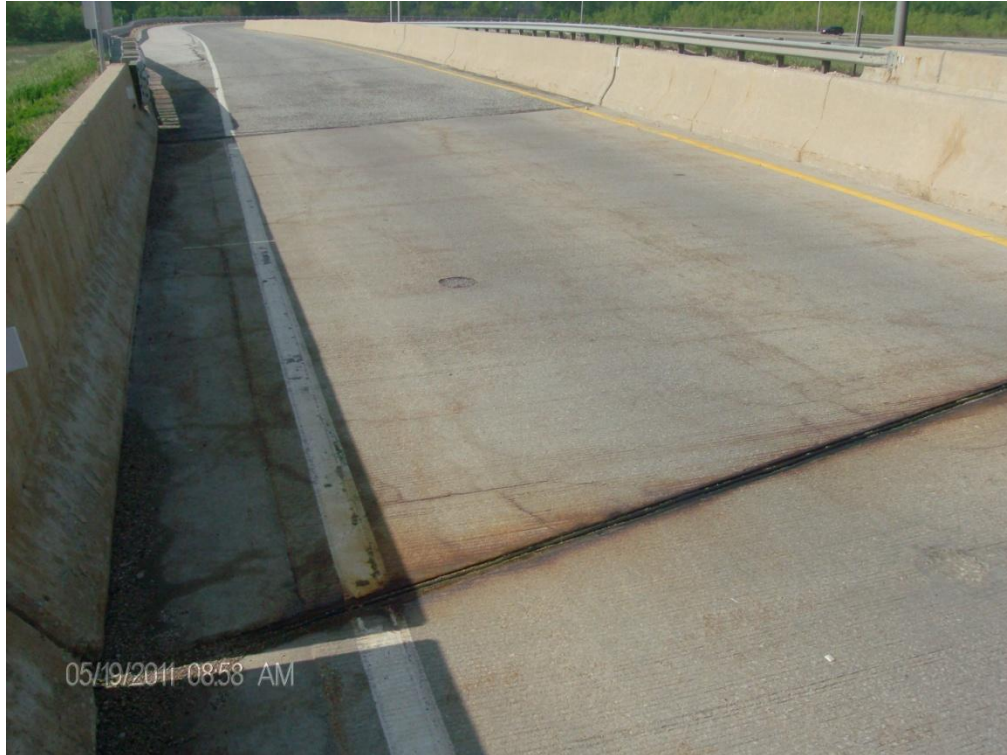
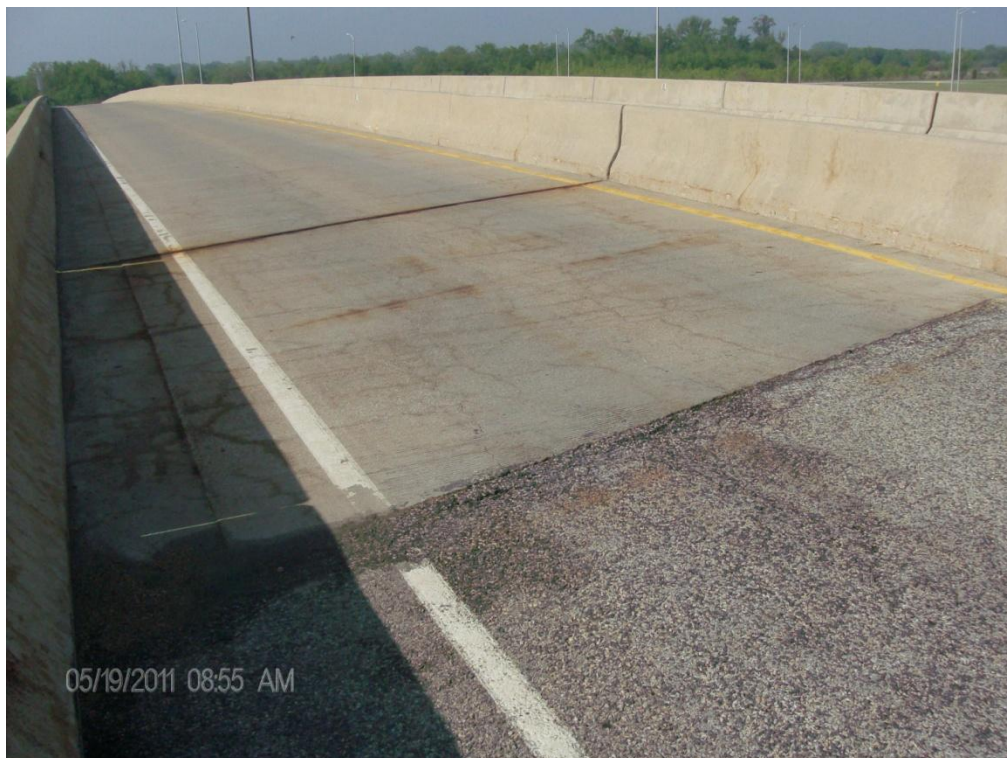
The tops of approach slabs were sounded for delaminations. There is a fair amount of map cracking, but spalling is minimal and the overall top of approach slab condition is good. For typical conditions, see Attachment B – photos 15 and 16.

**Photo 15: NB side of South Approach**

**Photo 16: NB side of North Approach**

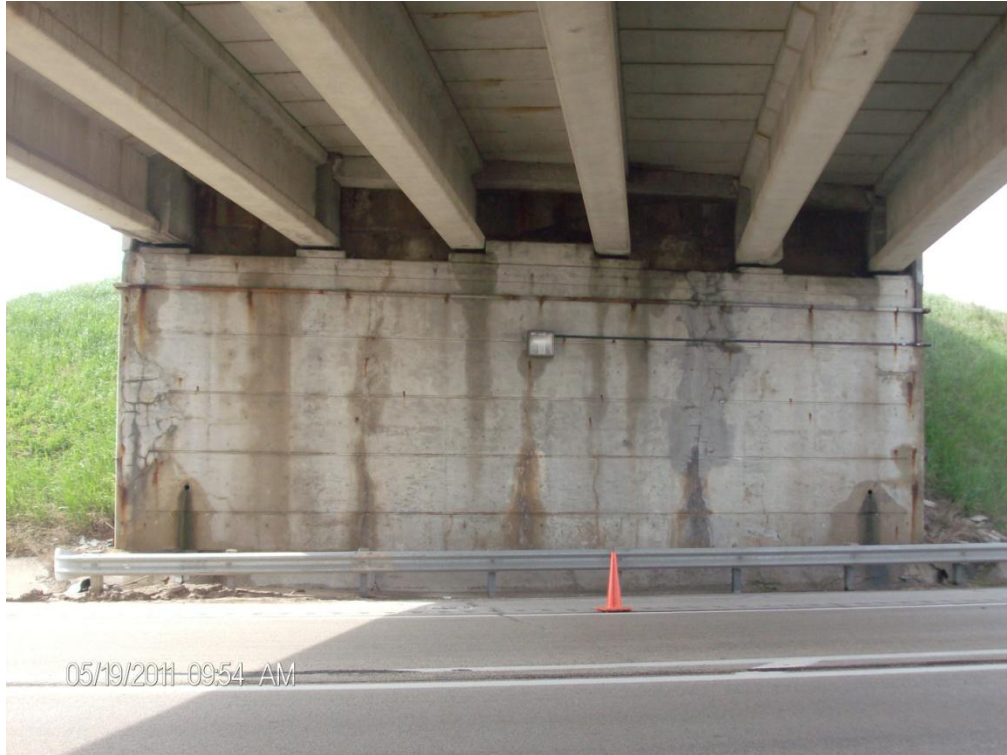
The substructure was rated as fair (NBIS Rating = 5) in the 2010 Structure Inspection Field Report. The substructure condition observed in this field inspection concurs with the previous rating. Approximately 17% of the South Abutment face and 10% of the North Abutment face is spalled or delaminated. The South Abutment has one injectable crack ( $\geq 1/16$ ”) and several hairline cracks. The North Abutment had only hairline cracks. All abutment cracks were vertical. For abutment elevations, see Attachment B – photos 17 and 18. The abutment backwalls were in worse condition. Approximately 45% of the South Abutment backwall and 40% of the North Abutment backwall was spalled or delaminated. The entire South Abutment backwall was observed to be wet during light rain. About half of the North backwall was wet during the light rain.

**Photo 17: South Abutment Elevation**

Both front walls will be repaired with this standard repair procedure.

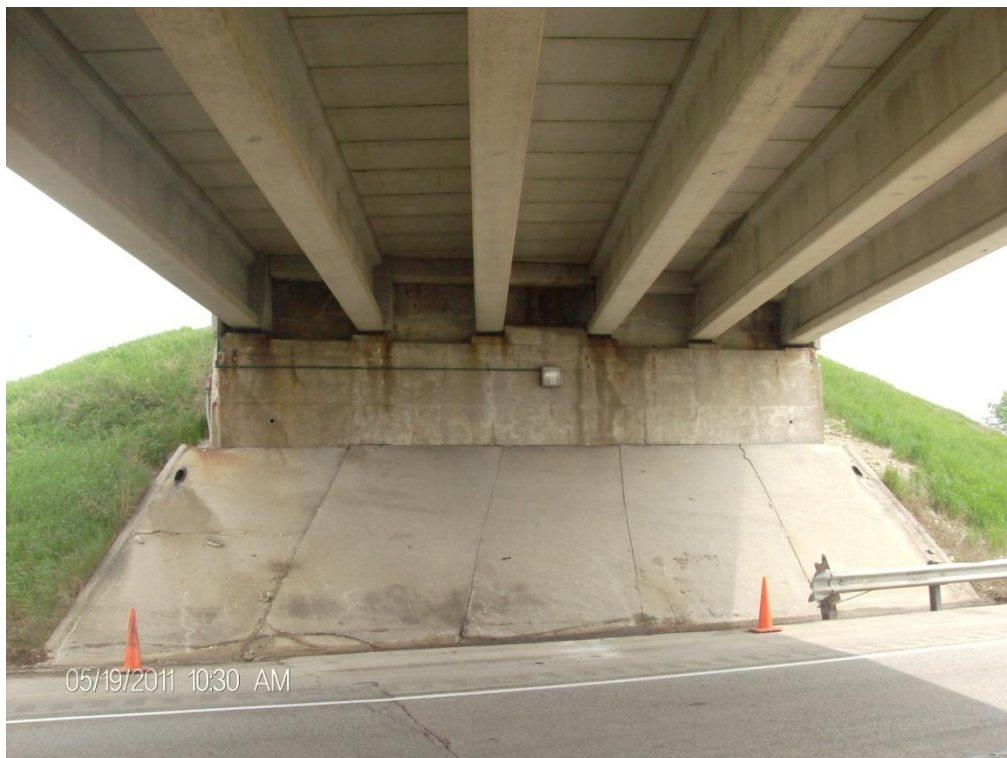
**Photo 18: North Abutment Elevation**

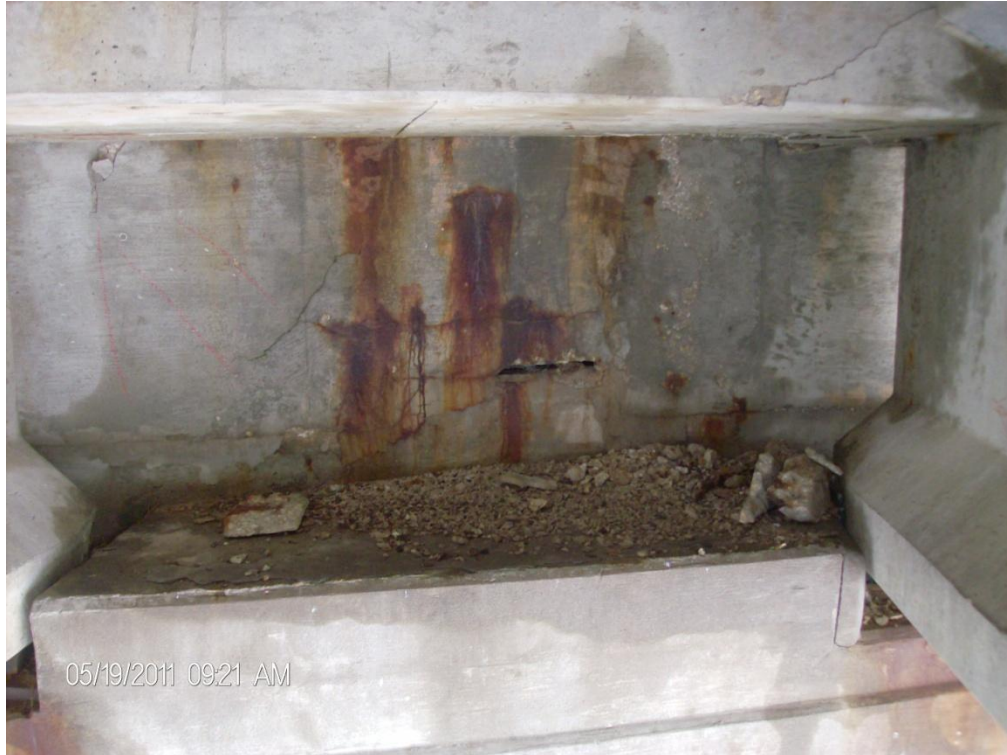
Debris was found along the entire South Abutment bearing seat length and along about 60% of the North Abutment bearing seat length. For an example of debris build-up, see Attachment B – photo 19. Debris was piled especially high between Beam 1 and the screen wall at both abutments, causing screen wall deterioration. See Attachment B – photos 20 through 22. Minor spalls were found on the North Abutment bearing seat between Beams 3 and 5.

**Photo 19: Debris build-up between Beams 3 and 4 at the North Abutment**

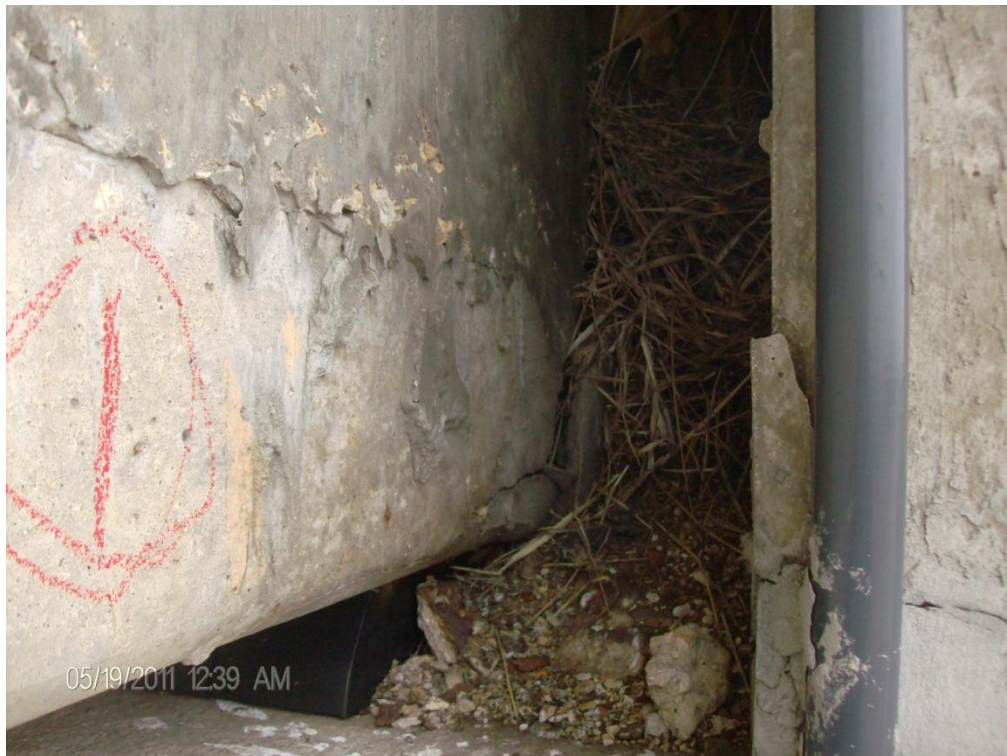
**Photo 20: Excessive debris between Beam 1 and screen wall at the South Abutment**

These 4 small walls adjacent to the ends of the fascia beams are non-functional architectural features. They trap debris, promote deterioration of the beam ends and bearings, and are a hindrance in the repair of structural elements. The conditions of these walls range from satisfactory to poor.

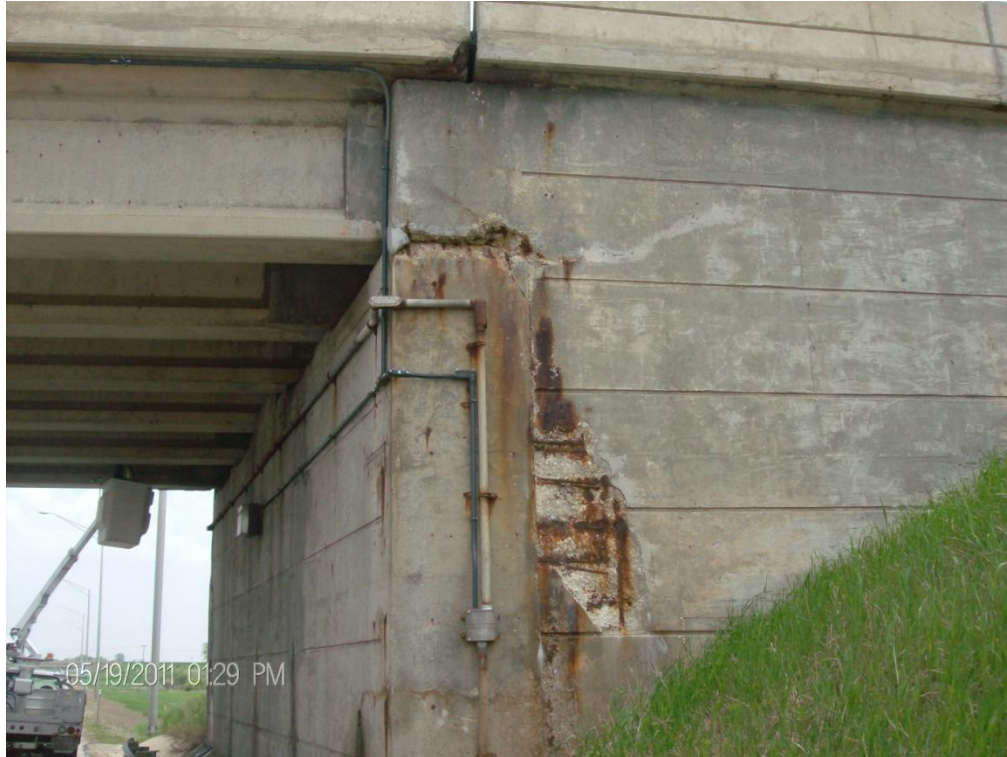
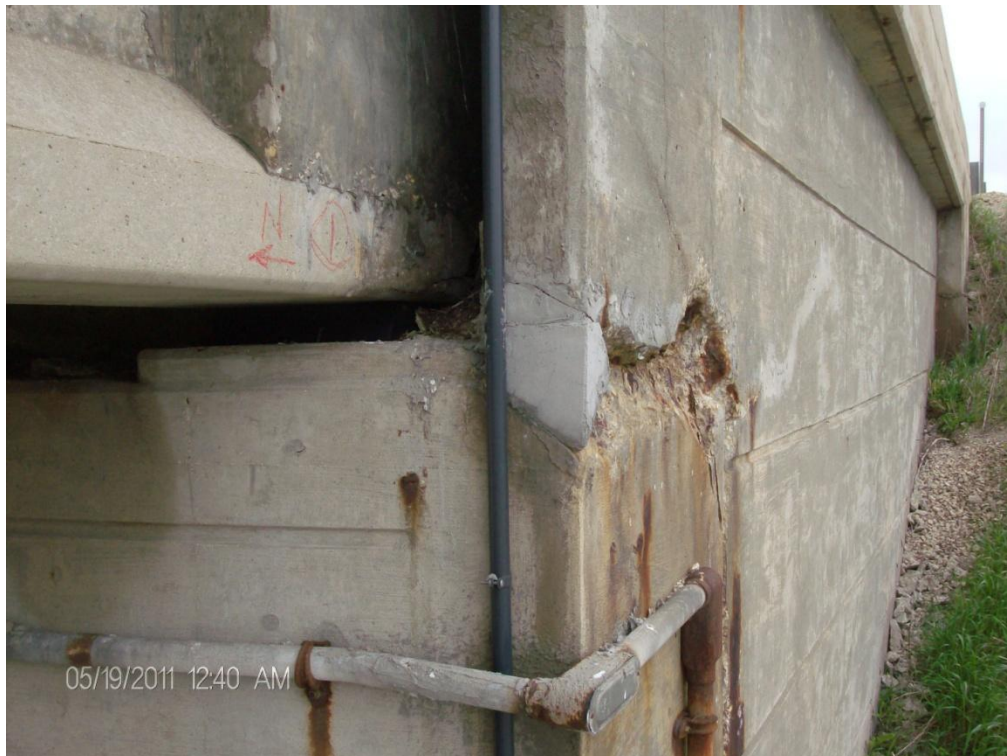
At the southwest curtain wall, there is a 10' long x 3' wide x 3' deep washout exposing the wall underside, near the top of the slope. The wall underside is exposed for about 5 feet. Additionally, there is approximately 36 ft<sup>2</sup> of spalling near front of the wall. See Attachment B – photos 21 and 22. There is also cracking along the wall, but all cracks are less than 1/16" wide.

**Photo 21: Southwest Curtain Wall Elevation**

**Photo 22: Spalling and deterioration at the Southwest Curtain Wall and Screen Wall**

This repair will be performed at the southeast and southwest curtain walls. This repair will consist of filling the exposed void under the curtain walls with concrete, covering the embankment void with geotechnical fabric and then adding riprap or aggregate.

This four curtain walls will be repaired with this standard repair procedure.

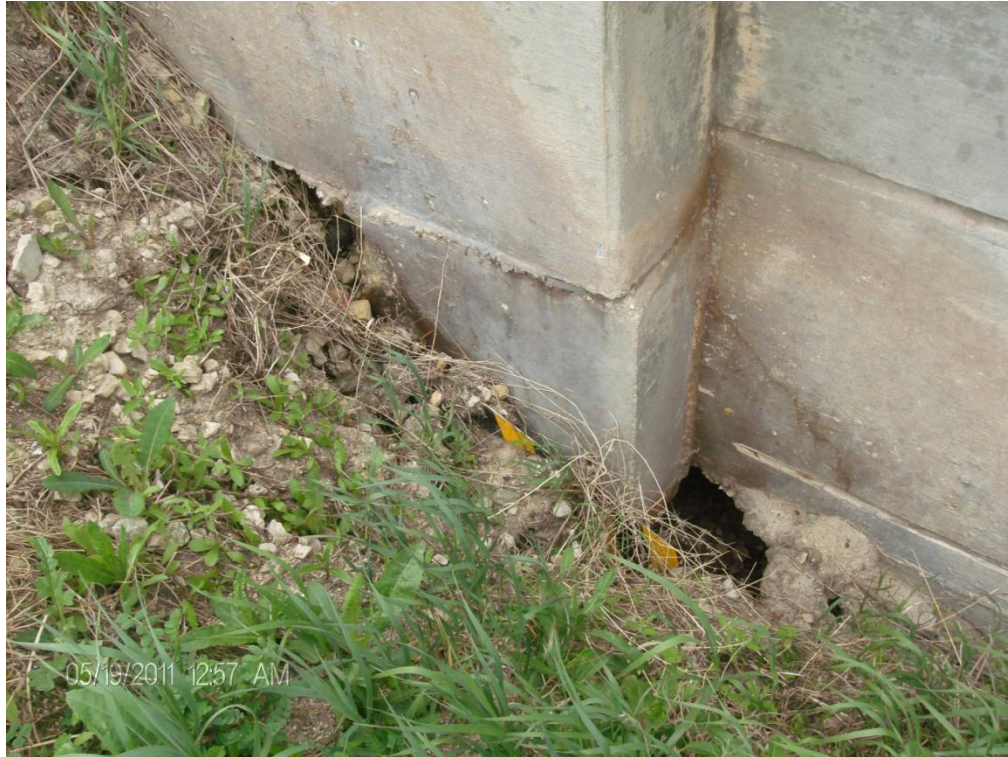
At the southeast curtain wall, there is an 18' long x 3' wide x 3' deep washout exposing the wall underside, near the top of the slope. The wall underside is exposed for about 12 feet. See Attachment B – photo 23. Additionally, there is approximately 9 ft<sup>2</sup> of spalling near the front top corner of the wall. See Attachment B – photo 24. There is also cracking along the wall, but all cracks are minor.

**Photo 23: 18' long x 3' wide x 3' deep washout at the Southeast Curtain Wall**

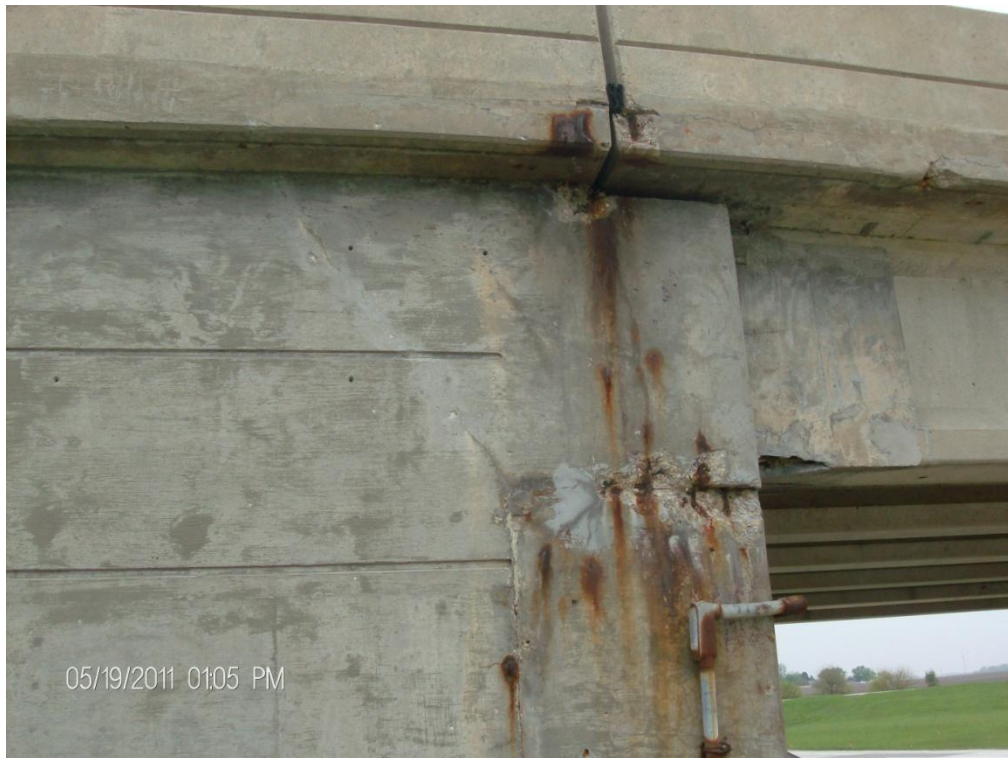
**Photo 24: Spalling on Southeast Curtain Wall**
